## NTS 02-G & NTS 03-G+ Firmware Release Notes

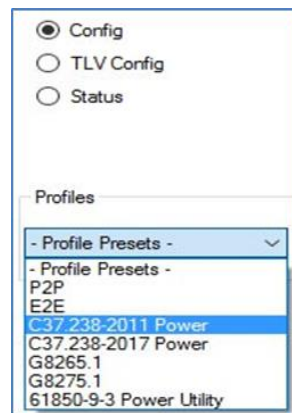
- **Feature:** PTP C37.238-2017 and 61850-9-3 Power Utility profiles have been added. Tekron Configuration Tool 4.3.1.5 or later is required to select these Profiles.
