NTS 02-E & NTS 03-E Firmware Release Notes

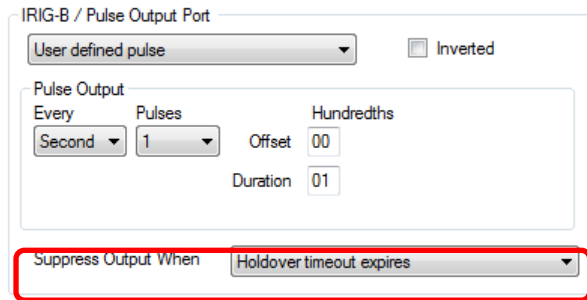
This applies to the following ports:

- P3 configurable IRIG-B / Pulse output port
- P6, P7, P8, P9, P10, P11 configurable IRIG-B / Pulse output ports
